378' WHEC EXPANSION JOINT INSTALLATION
AND PERFORMANCE EVALUATION

Luis M. Baez, et al

Coast Guard Research and Development Center

July 1974

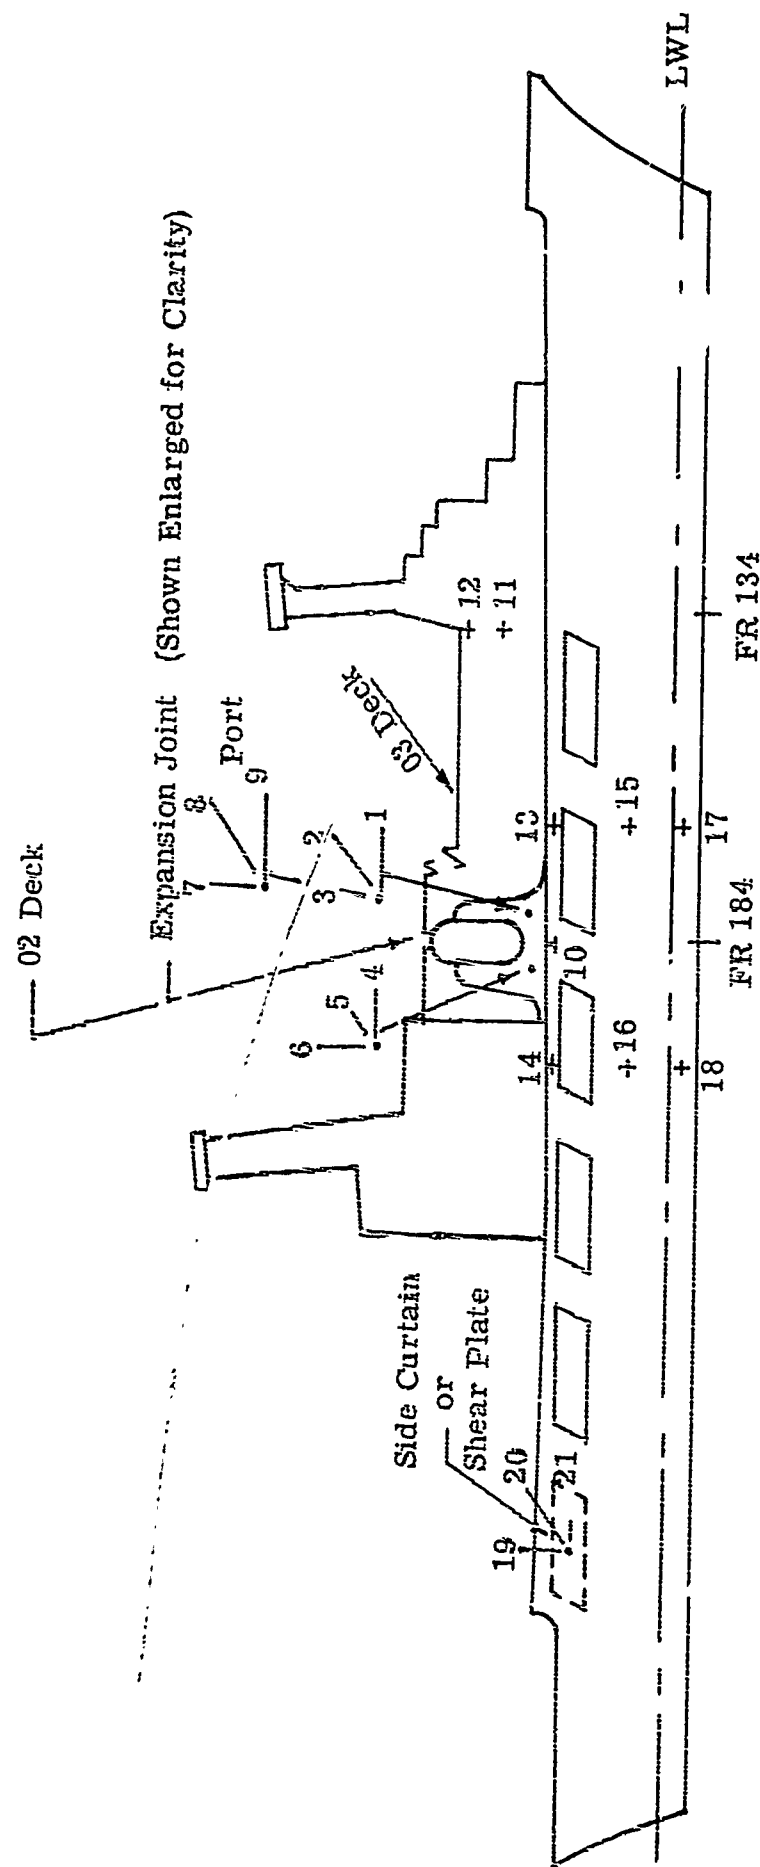
STRAIN GAGE LOCATIONS PHASE I

Due to the failure of the 01 deck plate gauges (Figure 8, gauges #13 and #14) installed ten feet fore and aft of the expansion joint hinge, it was not possible to ascertain the 01 deck plating longitudinal stresses simultaneously with the principal stresses at the hinge; however, by correlation of the data obtained in Phase II (Figure 9, gauges #3, #4, #7 and #8), it is seen that the hogging and sagging-induced longitudinal stresses in the bottom portion of the hinge plate are of the same order of magnitude as the 01 deck plating stresses just forward and aft of the expansion joint.
